# Manhole Inspection Summary

Manhole # S13SS\_013MH

Insp Date: **8/12/09 12:28 PM**

**Location** Address: **DUKELAND AVE**

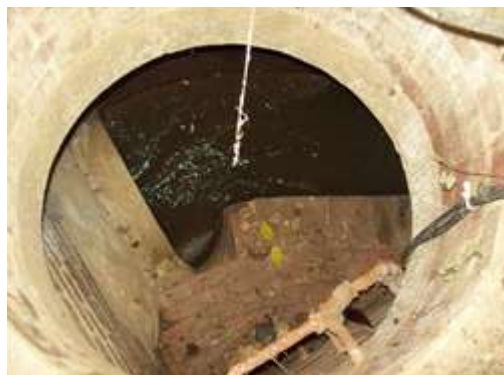
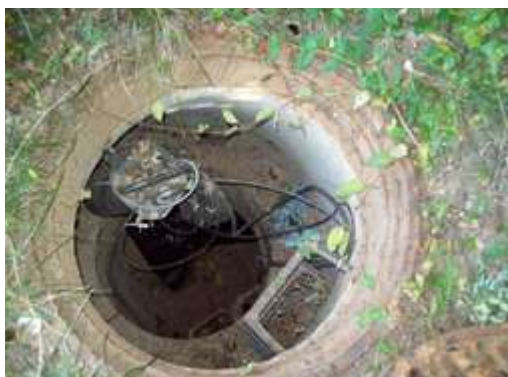
Top View

Comments **MH IS INLINE, THIRD LINE DOES NOT EXIST, MH has meter in it, top view can't show the whole connectivity**

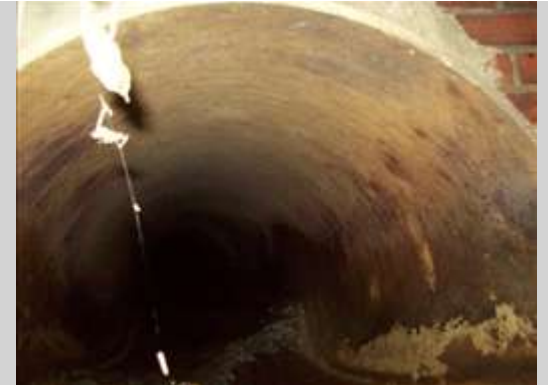
12 O'Clock Outflow

27 in. Circular Gravity Sewer  
Pipe Out @ 12 O'Clock

Pipe Height: (in.) Direct  
Pipe Material: **PVC** ☐ Pipe Lined  
Invert Depth: **10.78** (ft.) Flow Characteristics: **Turbulent**  
Deposits: ☒ None ☐ Mud ☐ Sludge ☐ Debris ☐ Grease  
Silt Depth: (in.) Deposits Extent:  
Infiltration: **None** Pipe Seal Cond: **Sound**

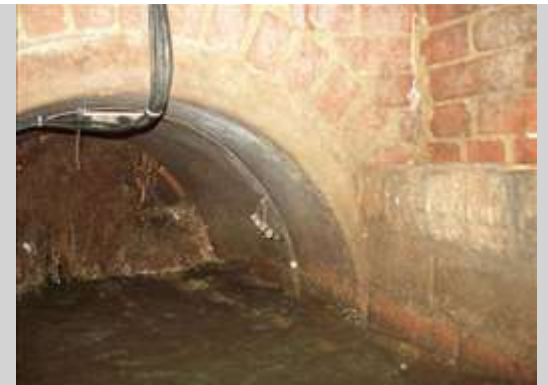
6 O'Clock Inflow

27 in. Circular Gravity Sewer  
Pipe In @ 6 O'Clock

Pipe Height: (in.) Direct  
Pipe Material: **PVC** ☐ Pipe Lined  
Invert Depth: **10.94** (ft.) Flow Characteristics: **Turbulent**  
Deposits: ☒ None ☐ Mud ☐ Sludge ☐ Debris ☐ Grease  
Silt Depth: (in.) Deposits Extent:  
Infiltration: **None** Pipe Seal Cond: **Sound**
